**REPORT ON THE BELL INSTALLATION
AT THE CHURCH OF ST. GILES,
OXFORD.**

20th September, 2007

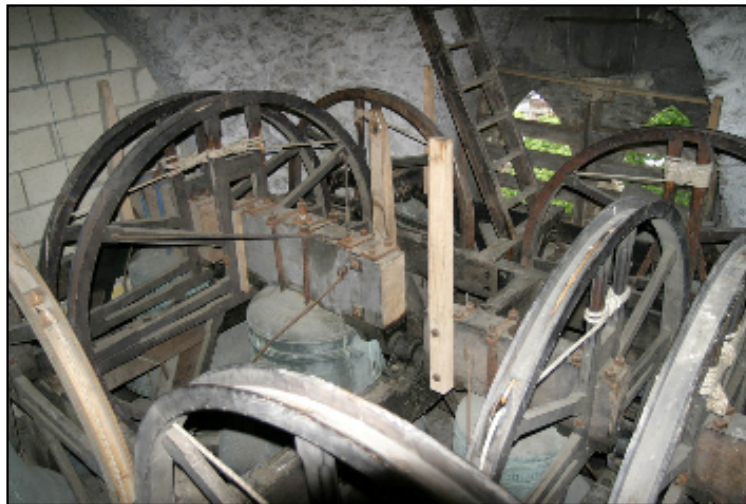
The timber frame is fitted with vertical tie-bolts and angle plates and the frame as a whole is in excellent order.

A view of the bell installation. (The 5th wheel is in the foreground)

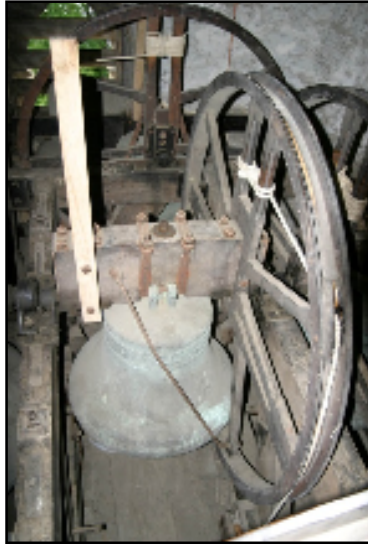
The 4th bell and its fittings

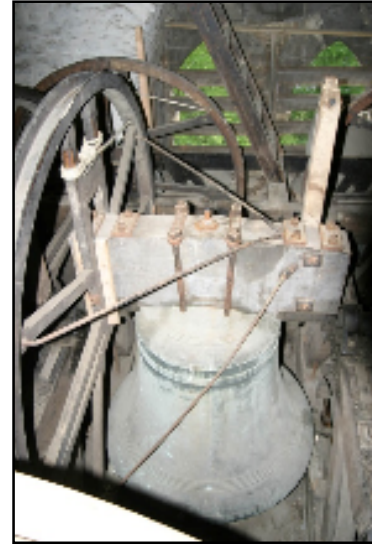
The tenor bell and its fittings.

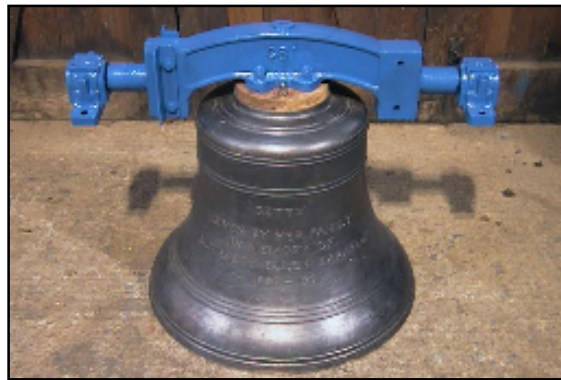
The proposed design of cast-iron headstock.

Cast-iron box-section headstocks with fixed steel gudgeons, heavy duty double row self-aligning ball bearings in totally enclosed dust-proof housings and adjustment screws to facilitate the setting and maintaining of even clapping.
